# **ELEMENT 2**

## **Field Investigations**

**ASCE STRUCTURES CONGRESS**

**CUREE-Caltech Woodframe Project**

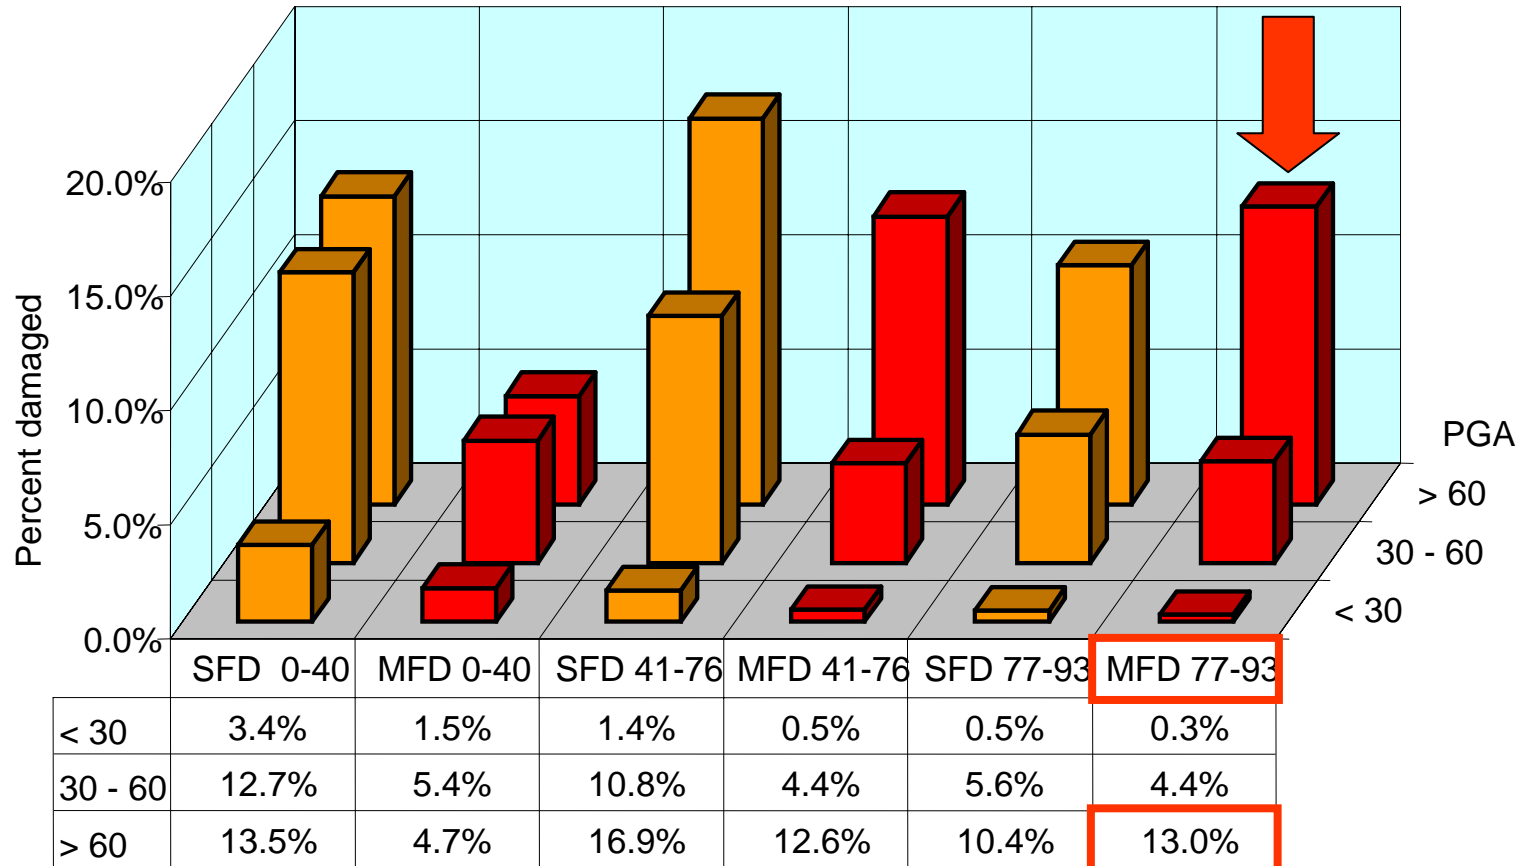
Graph 2-2b: Damaged Projects as Percent of Existing

# Highest % damaged: MFD built since '76 (General study)

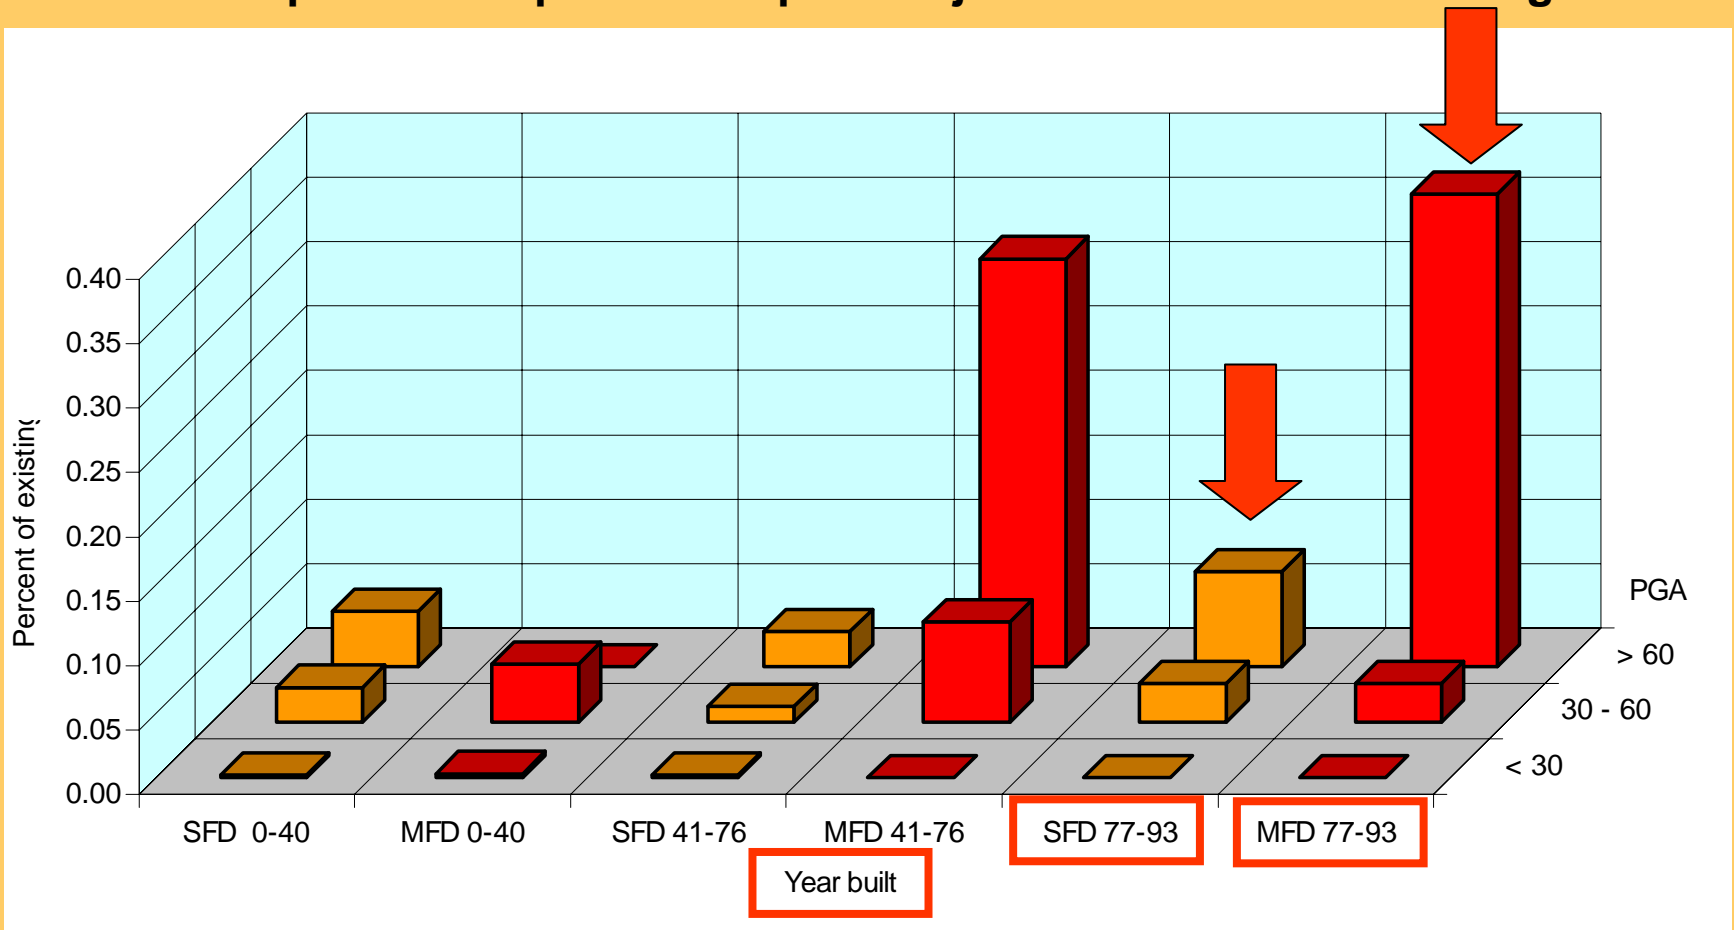
Graph 5-1b: Expensive Repair Projects as Percent of Existing

# Highest % damaged: MFD & SFD built since '76 (Expensive repair study)

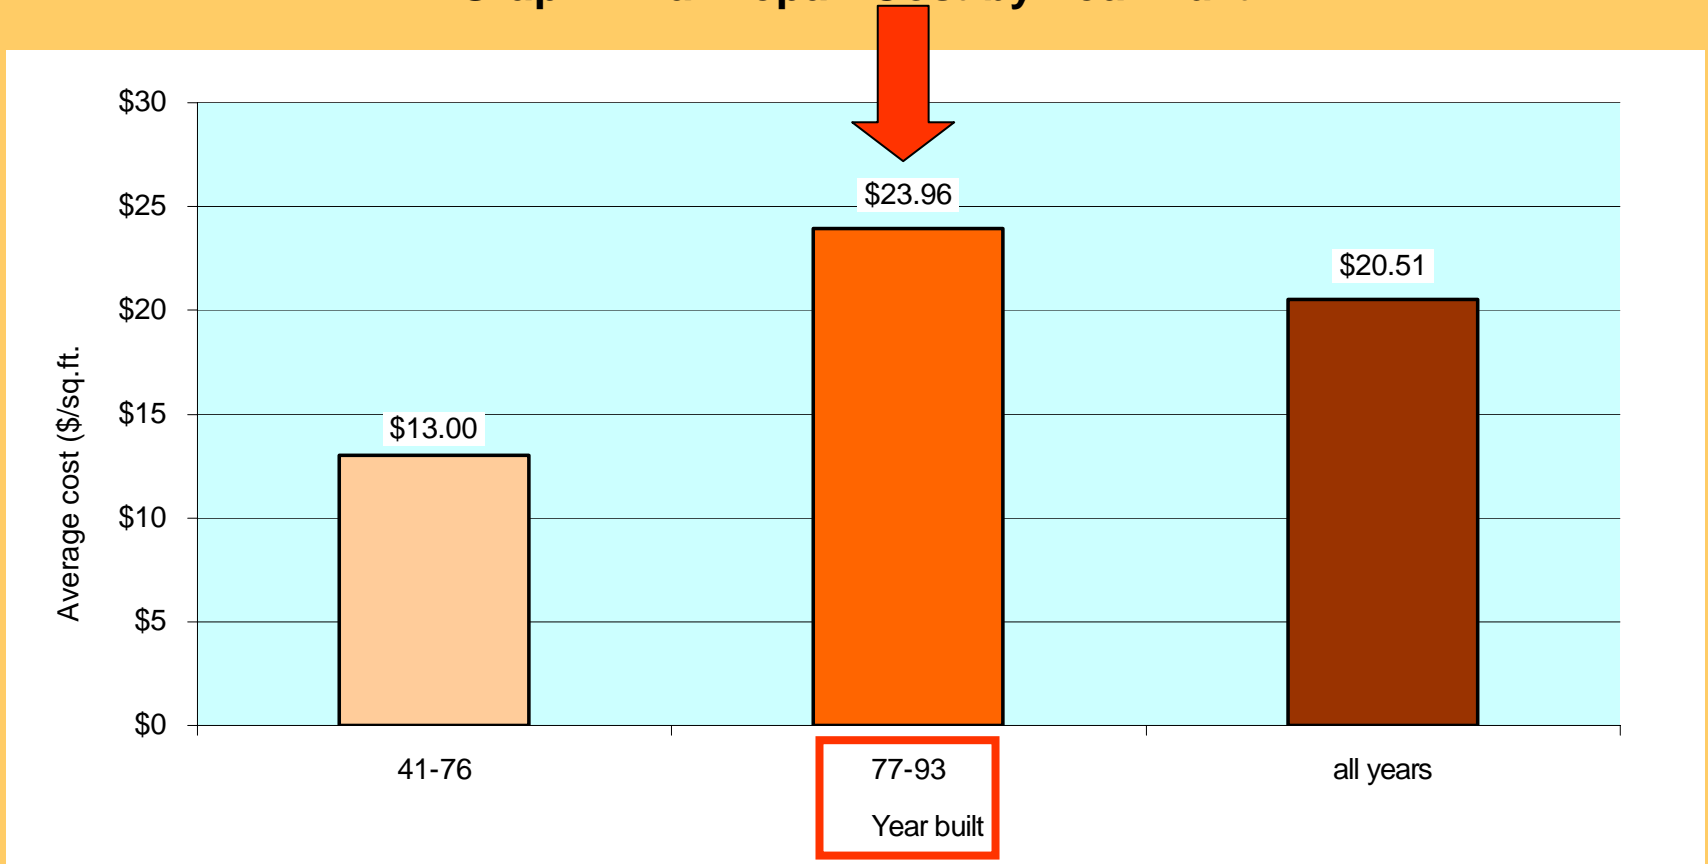
Graph 4-2a: Repair Cost by Year Built

# Highest repair cost: MFD built since '76 (Tuck-under parking study)

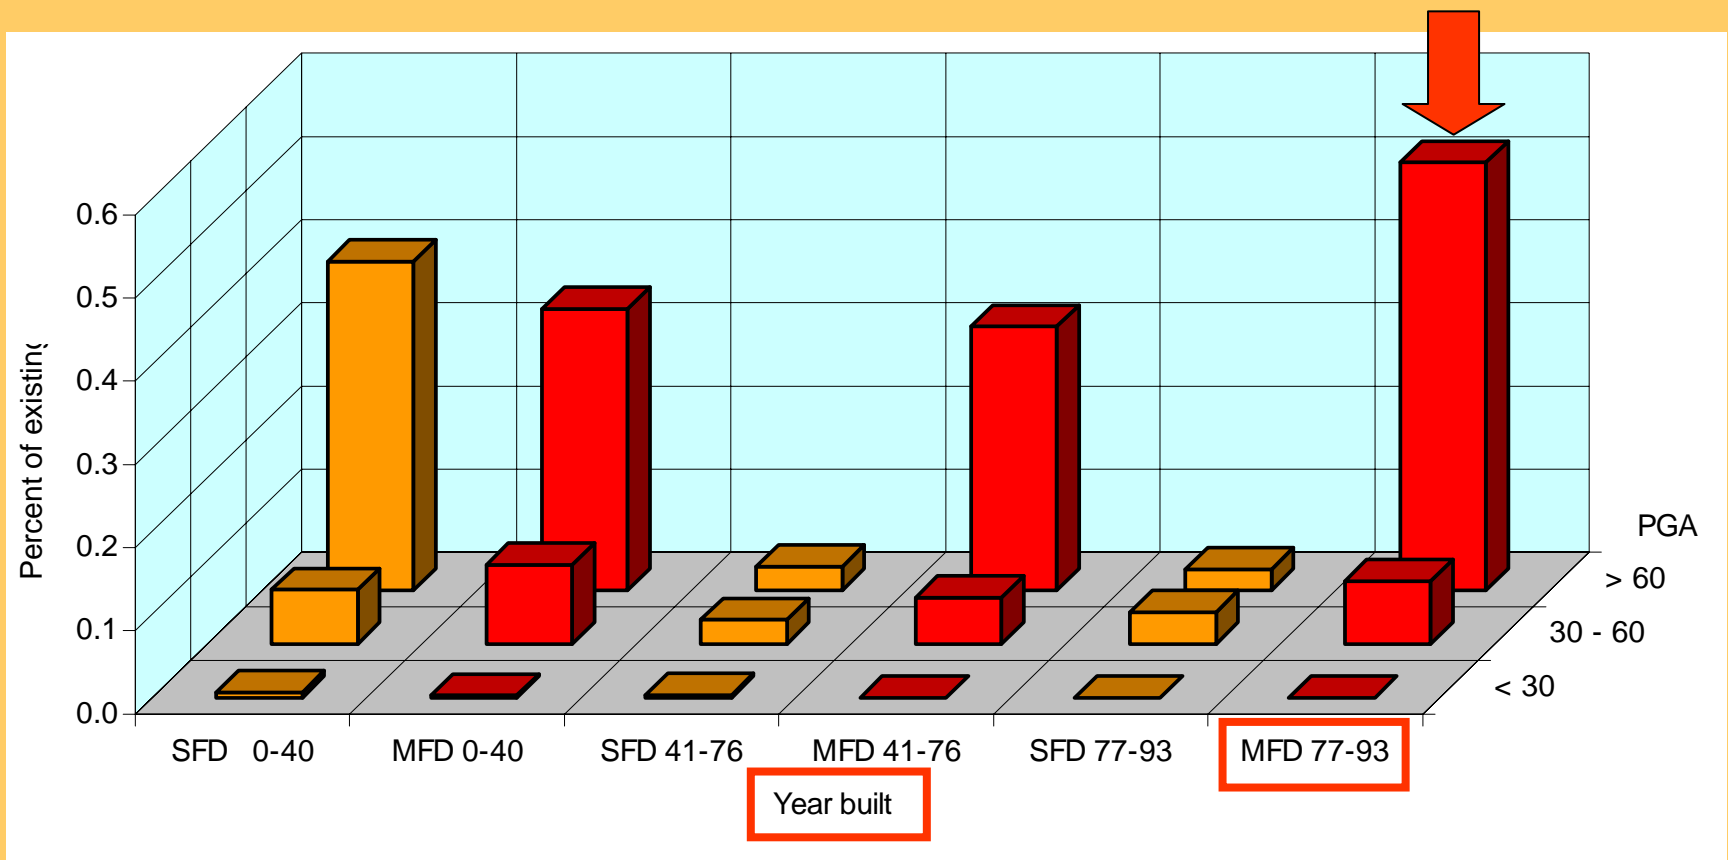
Graph 6-1b: Demolished Projects as Percent of Existing by Year Built and PGA

# Highest % demolished: MFD built since '76 (Demolished projects study)

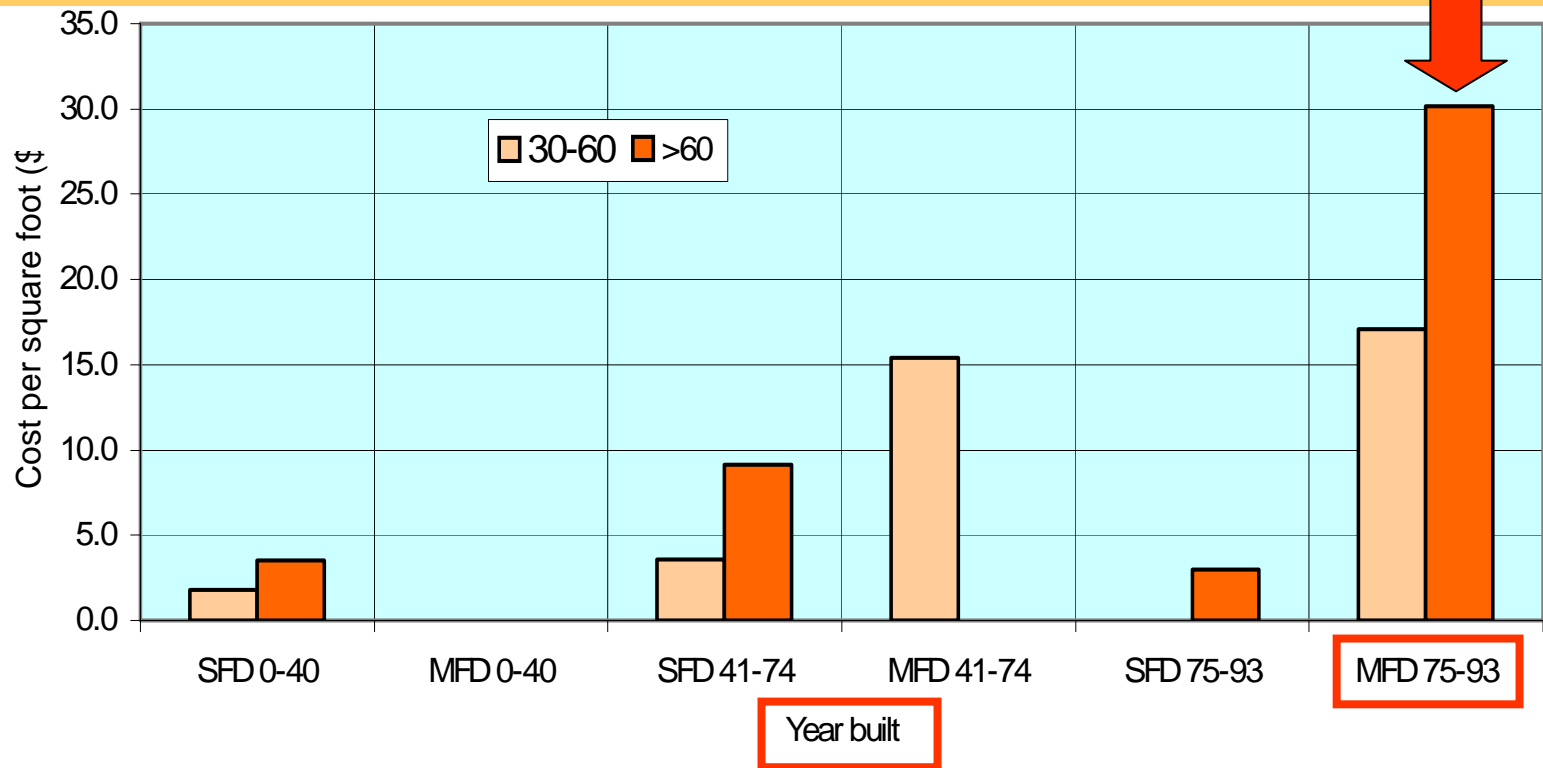
Graph 7-7a: Average Unit Repair Cost by Year Built and PGA

# Highest repair cost: MFD built since '76 (NAHB follow-up study)

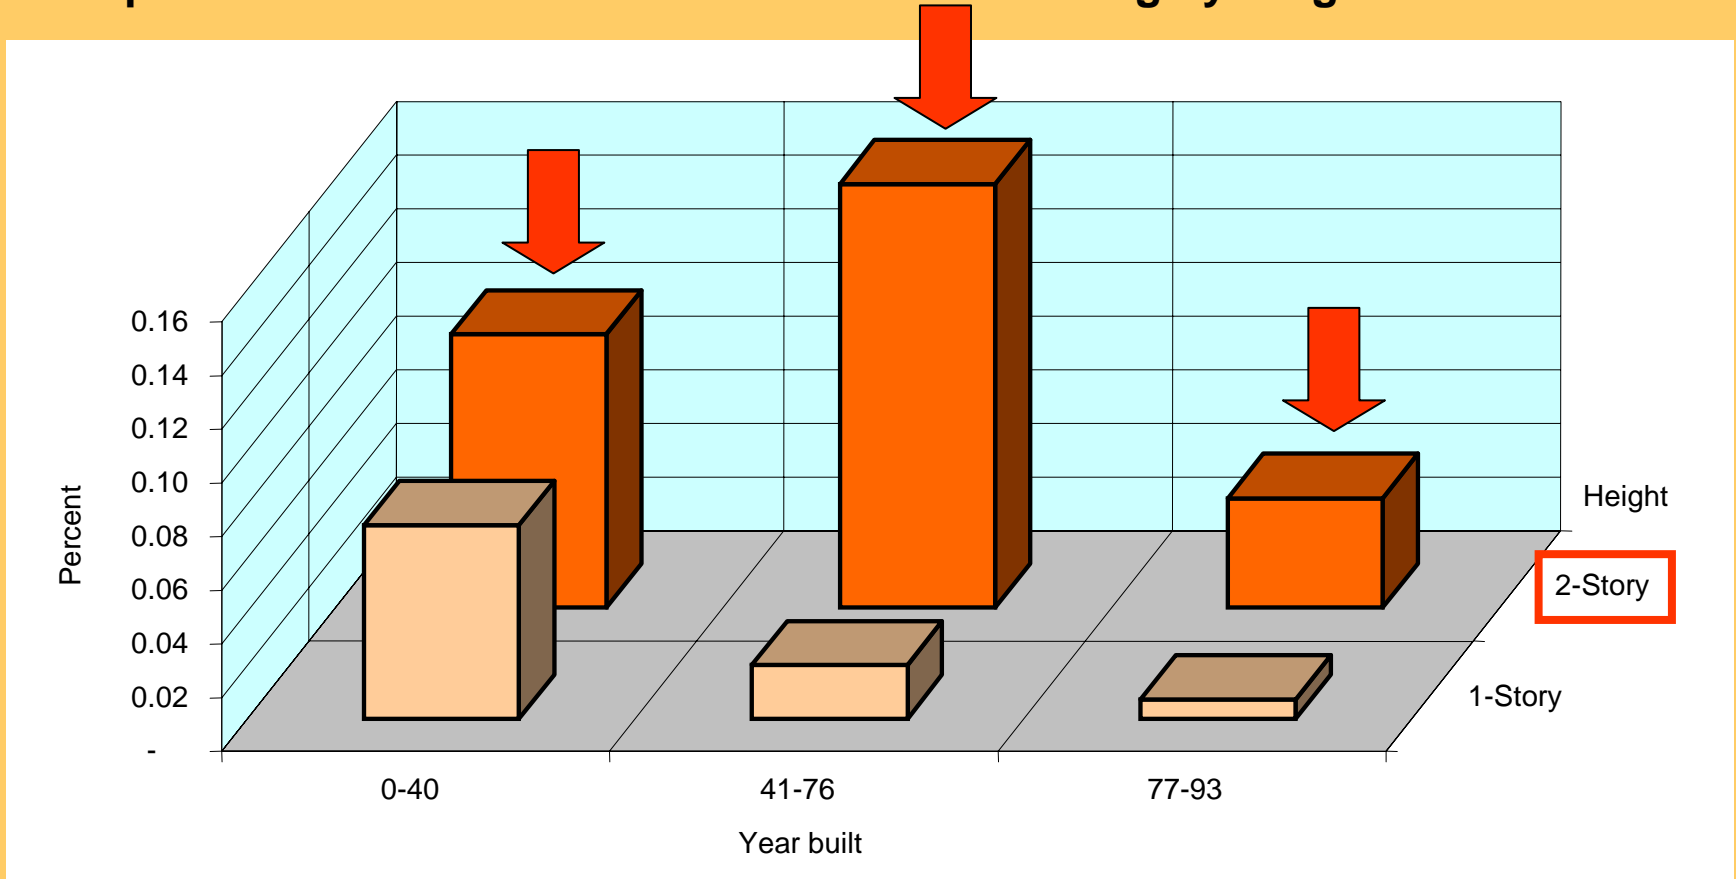
Graph 6-2b: Demolished SFD as Percent of Existing by Height and Year Built

# Two-story SFD have the highest % demolished (Demolished projects study)

*The resonant period of about 0.2 seconds of 2-story SFD may have caused the failure*

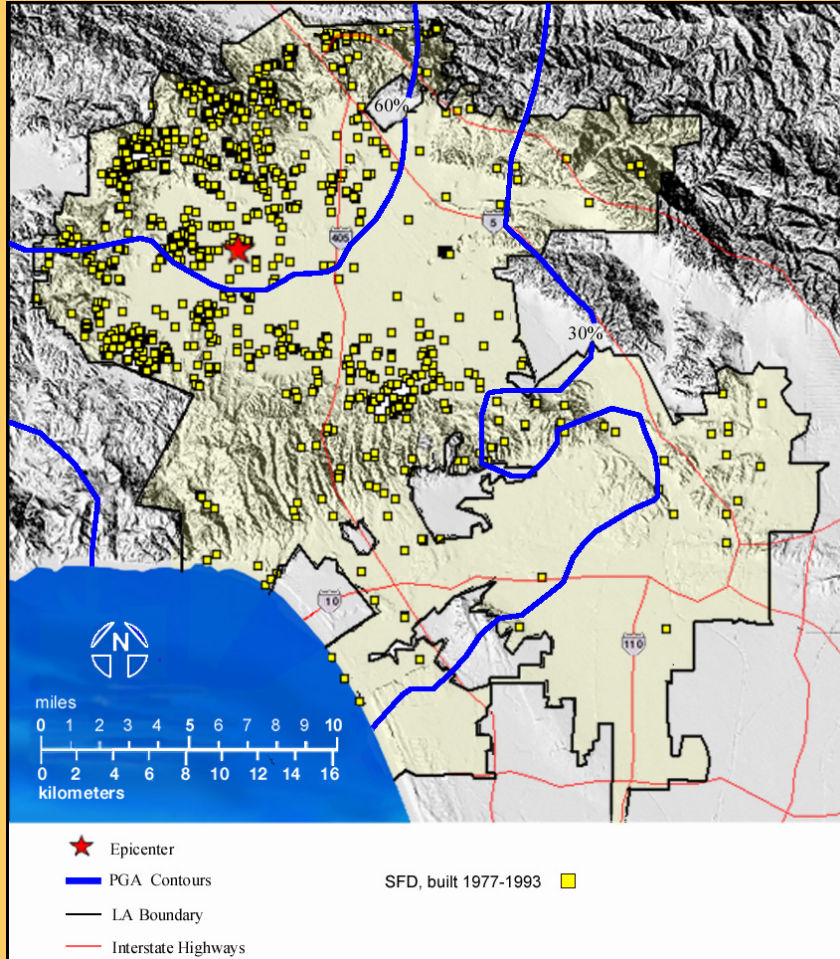
Map 2-5b: Damaged SFD, Built 77-93  
at **PGA** Contours

# Damage correlates better with PGA than PGV
