JOURNAL OF PERFORMANCE OF CONSTRUCTED FACILITIES

QUALITY CONTROL IN SEISMIC DESIGN AND CONSTRUCTION

By G. G. Schierle¹

ABSTRACT: This paper presents research on quality control in seismic-resistant construction. The research objective was to verify compliance with seismic safety features in light residential and commercial wood construction. While the study was on quality control in seismic-resistant construction, the results apply to wind conditions and design flaws as well. The study included two methods: (1) mail surveys of architects and engineers; and (2) site surveys of projects under construction. Results are presented in graphs for visual comparison. Both surveys revealed that more than one-third of seismic safety items were missing or flawed in over 40% of surveyed units (apartments, etc.). It is alarming that the key items to resist wind and seismic loads are among those most frequently missing or flawed, including shear wall hold-downs, nailing, and proportion (aspect ratio); wall-to-wall straps and tie-downs, diaphragm blocking and nailing, drag strut splice, and roof-to-wall anchors. Conclusions include recommendations to improve quality control.

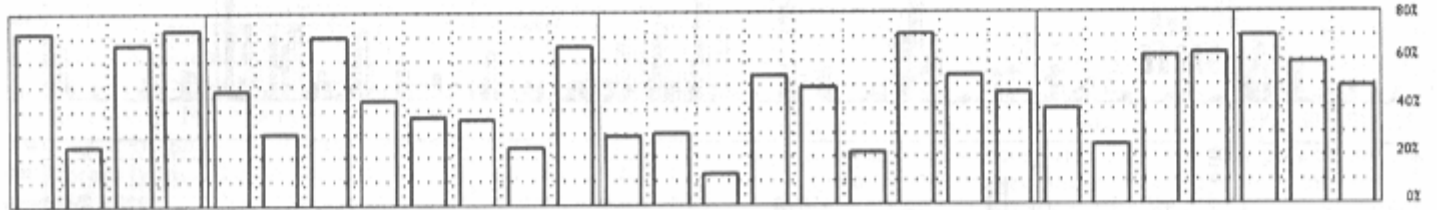
FIG. 1. Mail Survey

This graph includes in A and B, respectively, the "percentage of units with missing or flawed items" and "average percentage of missing or flawed items" illustrating the frequency and severity of problems. Graph A shows the frequency of problems as a percentage of units with missing or flawed items. For example, Item A1, anchor bolt, shows 72% of the units have missing or flawed anchor bolts. Graph B shows the severity of problems as an average percentage of missing or flawed items in two ways: as a percentage of all units and of flawed units. The latter is based only on units that have at least one of the respective items missing or flawed. For example, item A4, shear-wall hold-down, shows overall 15% hold-downs missing or flawed, but 20% when units with no missing or flawed hold-downs are excluded.

Some observations are of interest. The frequency of units with missing or flawed items ranges from a minimum of 13% to a maximum of 72%. Of the 28 items surveyed, 17 items are missing or flawed in over 40% of recorded units. Key items to resist seismic loads are among those that are most frequently missing or flawed, including shear-wall hold-downs and nailing; wall-to-wall straps and tie-downs; diaphragm blocking and nailing; drag strut splices; roof-to-wall clips; and tie-downs. These key items also have the highest severity rating, with more than 20% on average missing or flawed.

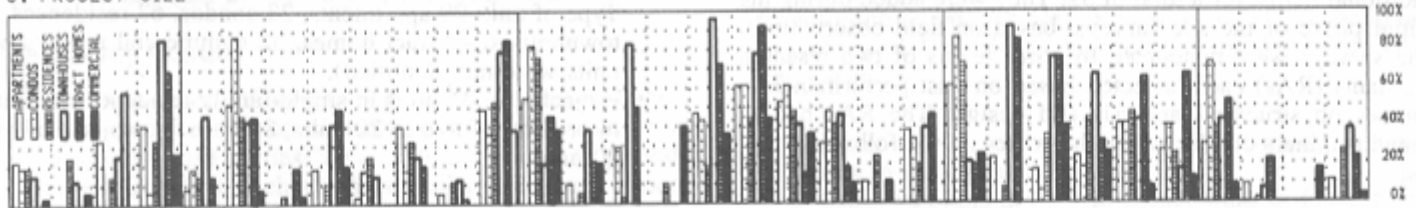
FIG. 2. Percentage of Site Survey Units with Missing or Flawed Items

This graph gives the frequency of missing or flawed items. For each item, it shows the percentage of units that have some of those items missing or flawed. The data is presented in graphs A, B, and C for "all units," "type of units," and "project size," respectively. For Example, Item A4, shear-wall hold-down, shows 45% of recorded units have missing or

flawed hold-downs. Graph A has missing or flawed items for all units. Graph B itemizes unit types by apartments, condos, etc. Graph C itemizes projects of one unit, two to 20 units, and over 20 units.

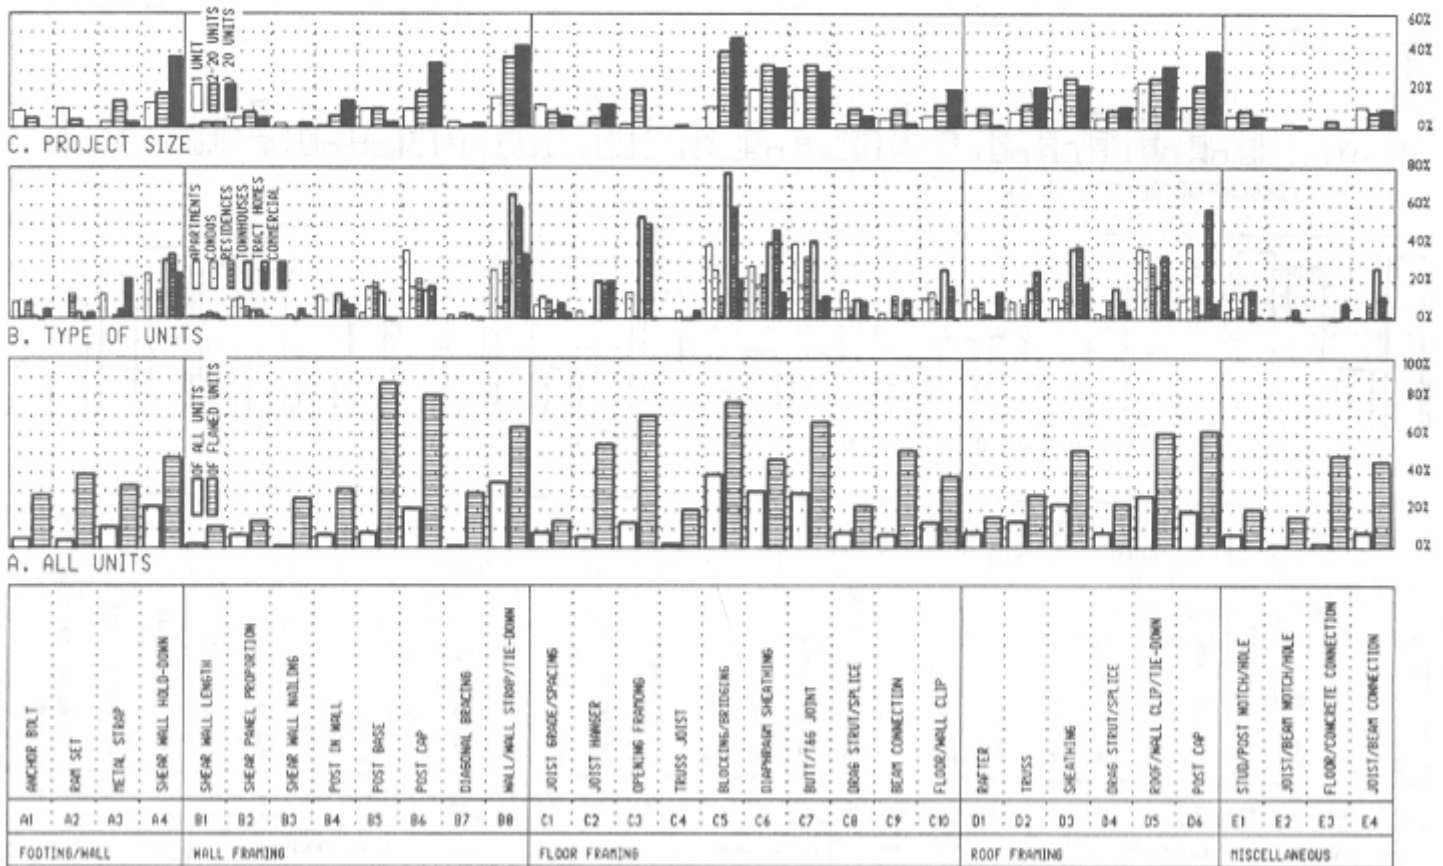
FIG. 3. Average Percentage of Missing or Flawed Items in Site Survey Units

This graph gives the severity of missing or flawed items. For each item, it shows average percentages by which the respective item is missing or flawed. The data are presented in graphs A, B, and C for "all units," "type of units," and "project size," respectively. Graph A has percentages based on all units and flawed units. For example, item A4, shear-wall hold-down, shows that 22% of surveyed hold-downs are missing or flawed. However, 48% of hold-downs are missing or flawed when the percentages exclude units without any missing or flawed hold-downs. Graphs B and C have percentages based on all recorded units. Graph B is itemized for apartments, condos, etc. Graph C is itemized by project size for one unit, two to 20 units, and over 20 units.

Again, some observations are of interest. The percentage of units with missing or flawed items ranges from a minimum of 4% to a maximum of 58%. Of the 32 items surveyed, 11 are missing or flawed in more than 40% of recorded units. As in the mail survey, key items to resist seismic loads are among those missing or flawed in over 40% of recorded units. They include shear-wall hold-downs, shear-wall proportion, wall-to-wall strap or tie-down, diaphragm blocking and nailing, roof sheathing, and roof-to-wall anchors. About 35% units have missing or flawed metal straps and drag strut splices. Compared to the mail survey, shear-wall nailing shows fewer problems because RAs did not know what nail type or spacing was specified and checked only for the UBC maximum spacing allowed. Single-family residences have the least problems, while town houses and tract homes have the most. Further, large projects have more problems than small ones.

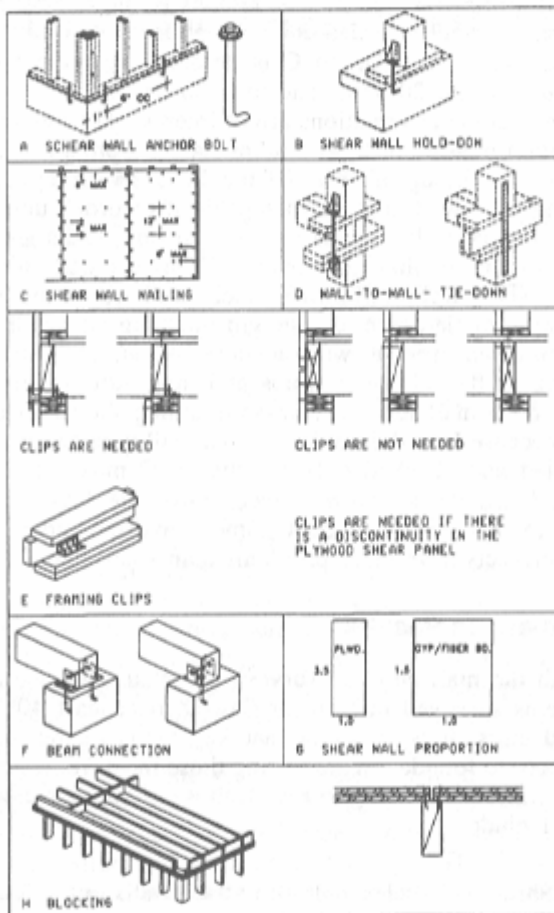
FIG. 4. Missing or Flawed Seismic Safety Items

Both the mail and site surveys revealed over one-third of the items surveyed missing or flawed in at least 40% of recorded units. It is alarming that key items in the load path from roof to foundation are among those most frequently missing or flawed. Referring to Fig. 4, those missing or flawed key items include

- A Shear-wall anchor bolt—to attach walls to the foundation to resist lateral slippage.
- B Shear-wall hold-down—to anchor walls to foundations to resist overturning under load.

- C Shear-wall nailing—to secure plywood panel edges nail spacing should be 6 in. (15 cm) or less per UBC (1991), yet many panels have nails spaced up to 16 in. (40 cm), or nails that miss framing members.

- D Wall-to-wall tie-down—to tie upper floor shear walls to those below to resist overturning.
- E Framing anchor—to tie roofs and floors to shear walls and walls to walls to transfer shear.

- F Beam connection—to secure beams from sliding off a wall or other support.
- G Shear-wall proportion—according to UBC table 25-I (1991) this should not be less than 1:3.5. The survey revealed walls of 1:18. This point, a likely design flaw, is discussed in the following section.

- H Blocking—of floor joists to nail adjacent plywood panel edges for shear transfer. Without it, diaphragms have only about one-half the shear capacity per UBC table 25-J-1.

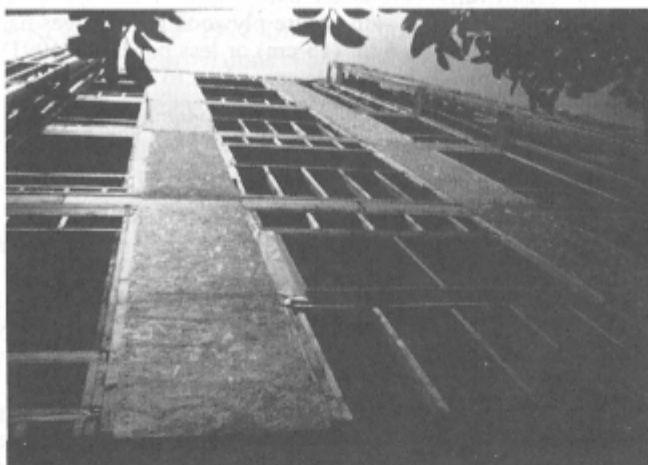
FIG. 5. Extremely Slender Shear Wall

According to UBC (1991) table 25-I maximum plywood shear wall width/height ratios should be 1:3.5 (a May 20, 1994 emergency enforcement measure of the Los Angeles Department of Building and Safety limits the ratio to 1:2). However, many shear walls surveyed exceeded the 1:3.5 limit substantially. The shear wall in Fig. 5 is 30 in. (75 cm) wide, ex-

tending five stories high for a ratio of 1:18 without being connected to moment-resistant beams at intermediate floors. Such walls are vulnerable to overturning and buckling under lateral load and clearly should be avoided. An architectural alternative to narrow walls would be to combine windows in adjacent rooms and to combine two shear walls into a wider one. This could be considered at an early design stage by preliminary computer analysis (Schierle 1992, 1994). An engineering solution would be to anchor the shear walls at each level to edge beams (rim joist), designed to resist overturning in bending.

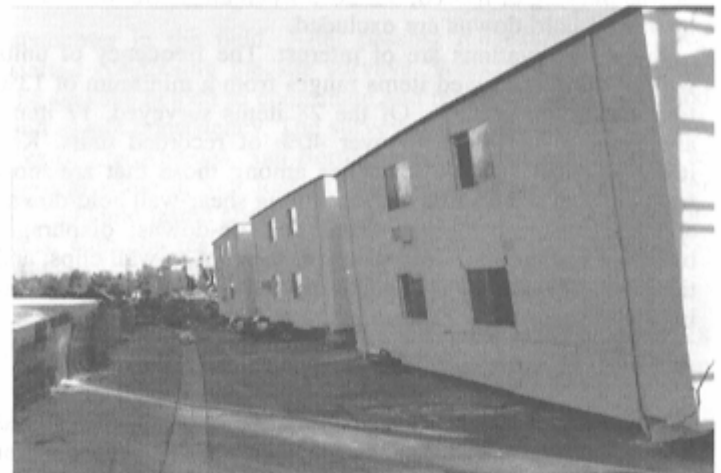
FIG. 6. Collapsed Soft-Story Parking

Soft-story parking under apartment buildings is often supported on columns that are pin-connected at the top and bottom, evidently under the assumption that lateral load would be transferred by floor diaphragms to side and rear walls in torsional shear. However, the frequent lack of blocking in floor diaphragms make them ineffective to transfer shear. The collapse of a soft-story parking in the Northridge earthquake (Fig. 6) is convincing evidence to seek better design practices. The supporting columns should be designed with moment-resistant connections to a grade beam and/or overhead beam of sufficient strength to resist lateral forces and sufficient stiffness to minimize $P\Delta$ moments.

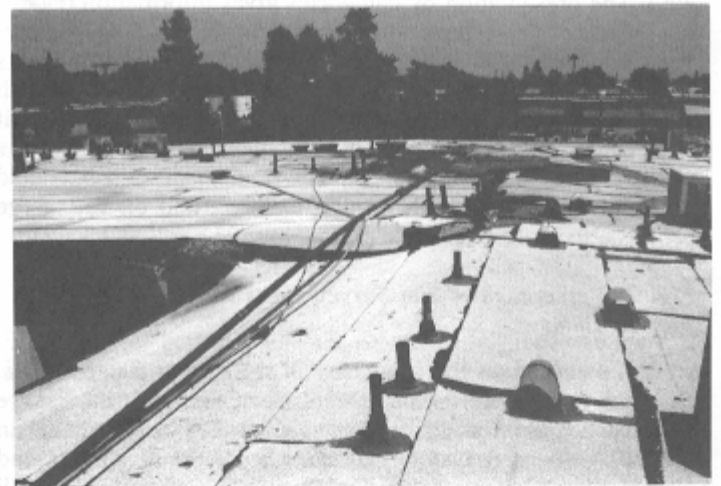
FIG. 7. Failed Roof Diaphragm at L-Shaped Intersection

Problem configurations of L-, T-, or U-shaped plans are common in apartment buildings. They are vulnerable to failure during earthquakes due to different stiffnesses (Arnold and Reitherman 1982). Vibration of a wing attached to an adjacent

wing of different periods may cause torsion (Fig. 7). To prevent failure, wings should be either separated by seismic joints or strengthened at their intersections.
