SEW/C2002

Structural
Engineers
World
Congress

Northridge Earthquake: Statistical Analysis of Damage to Residential Wood Structures

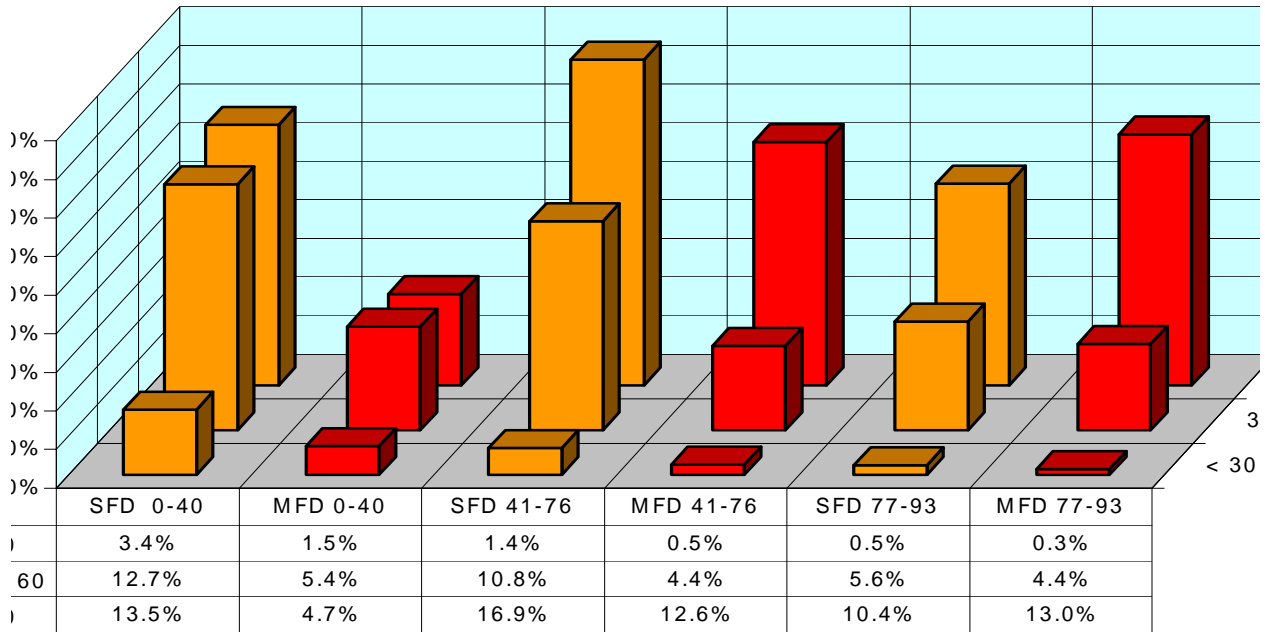
Graph 1: Damaged Projects as Percent of Existing

Multifamily dwellings (MFD) built 77-93 performed worse than older ones (graphs 1-7); contrary to what should be expected, since 1976 UBC changes require more conservative seismic design. Poor performance may be due to inadequate construction observations by design professionals.

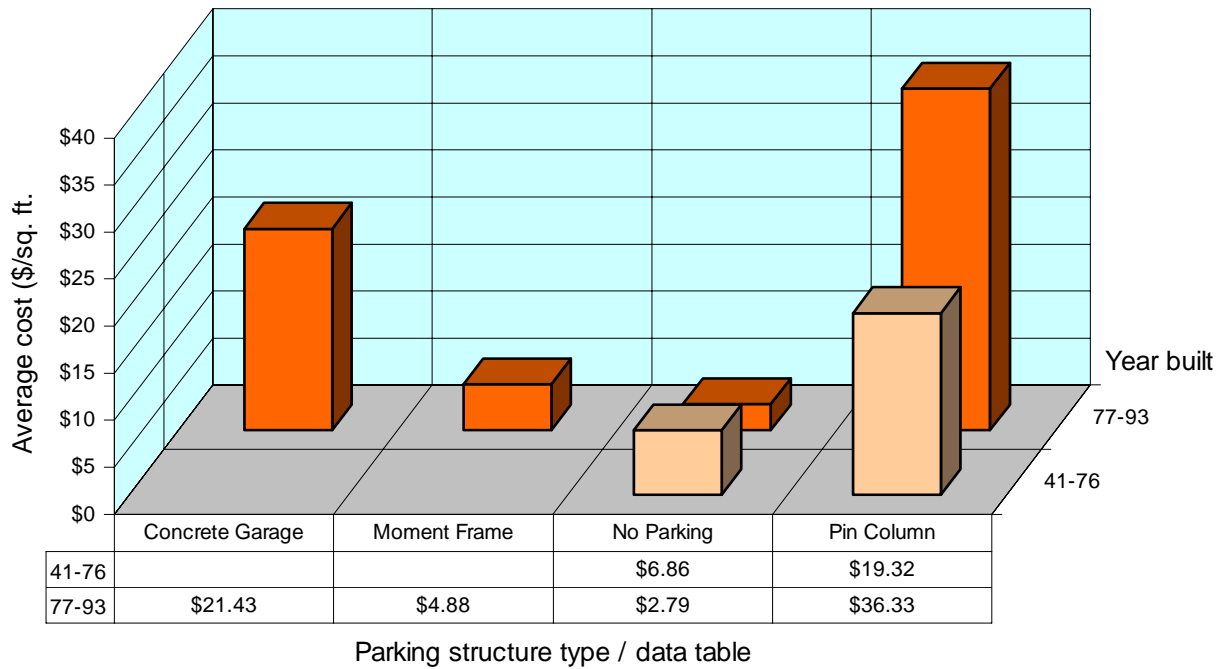
Graph 5: Repair Cost by Type of Parking Structure and Year Built

- Apartment buildings with tuck-under parking with pin columns did cost seven times more to repair than those with moment frame of the same vintage (graph 5).
- 59% demolished SFD are on hillsides, likely rock sites, while only 16% existed on rock sites.
- 31% demolished MFD are on hillsides, likely rock sites, while only 8% existed on rock sites.
- 88% of demolished MFD and 84% of demolished MFD were red-tagged.
- In MFD, shear walls are the most frequently damaged and the most costly item to repair.
- In SFD, footings are the most costly items to repair, while in SFD built before 1977, chimneys are the most frequently damaged items.
- In expensive repair buildings, non-structural items are most frequently damaged.
- Several collapsed buildings had tuck-under parking (soft-story).
- Roof diaphragm failure at intersection of irregular configurations caused major damage.

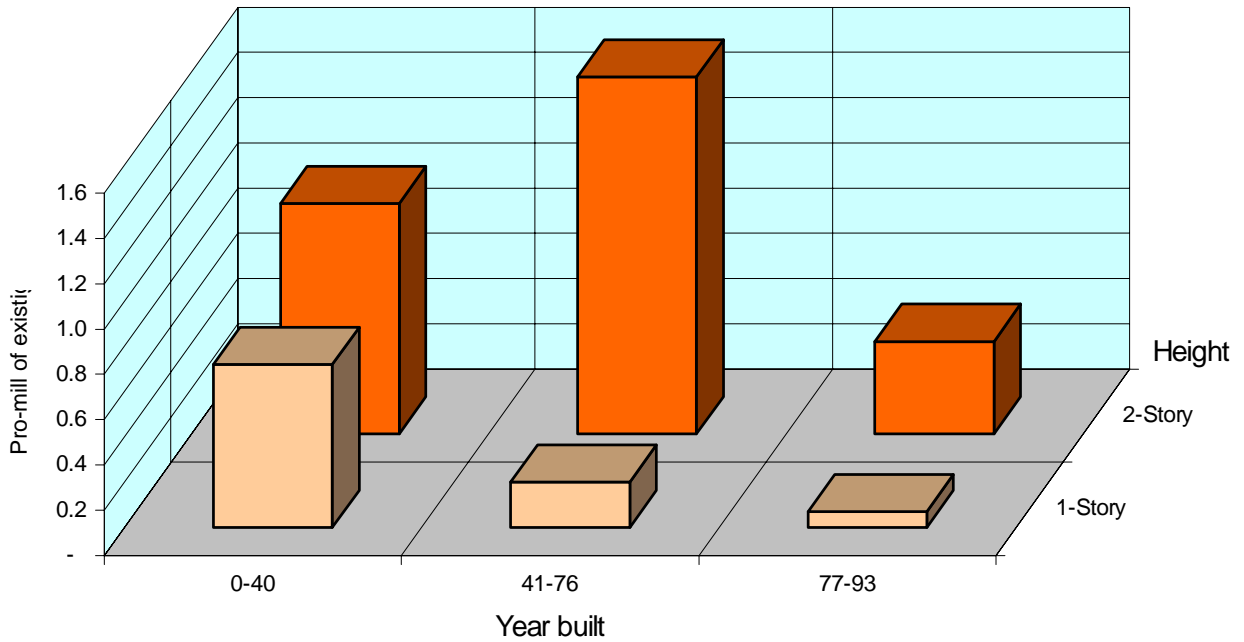
Graph 8: Demolished SFD as Pro-mill of Existing by Height and Year Built

As pro-mill of existing, most demolished SFD had two stories (graph 8). Their resonant periods of about 0.2 seconds correlates with the dominant ground period of about 0.2 seconds of the Northridge Earthquake and appears to be a major factor for their failure.

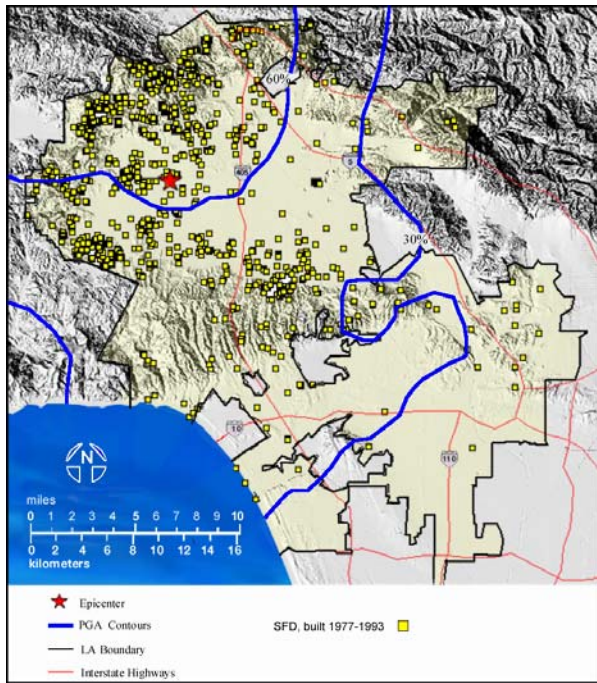
Map 1: Damaged SFD at PGA Contours

Damage patterns correlate better with PGA (Peak Ground Acceleration) than PGV (Peak Ground velocity) (maps 1&2, SFD built 77-93, are compelling examples). While this differs from a study by Dr. Boatwright, low-rise structures may correlate better with PGA due to short periods. The stock of existing homes in this example is rather uniform, hence damage is defined by seismic intensity, rather than existing home density.
