# **ELEMENT 2**

## **Field Investigations**

**ASCE STRUCTURES CONGRESS**

**CUREE-Caltech Woodframe Project**

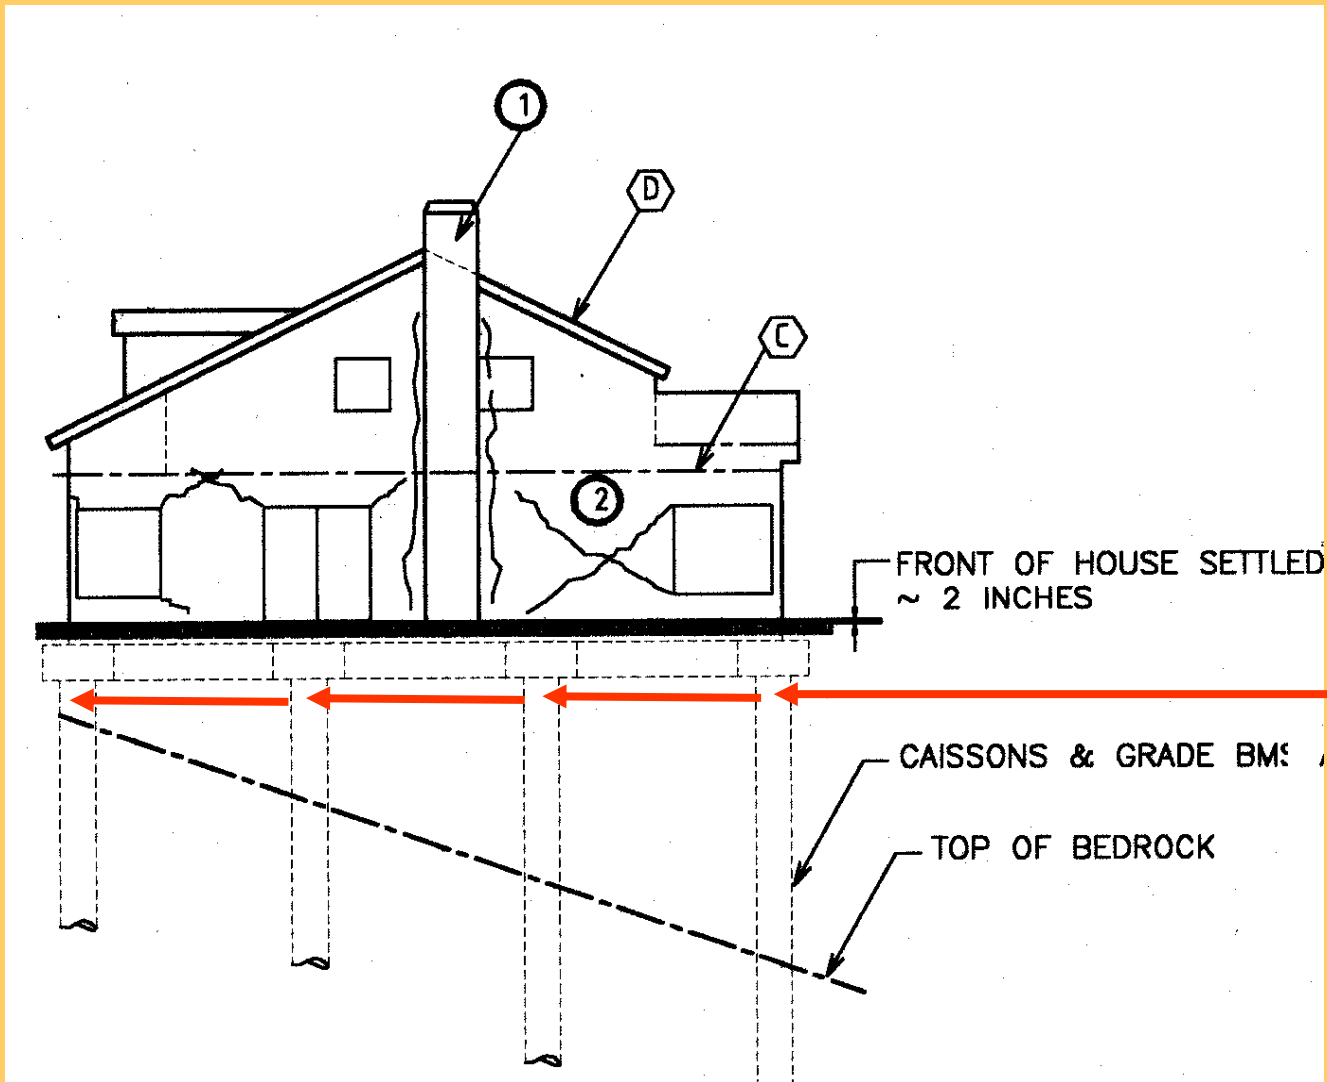
**To avoid  
expensive  
earthquake  
settlement  
repair .....**

# Adapt building to site – instead of adapting site to building

... to reduce grading and retaining walls and avoid expensive settlement repairs ☺
