SEW/C2002

Structural
Engineers
World
Congress

Northridge Earthquake: Statistical Analysis of Damage to Residential Wood Structures

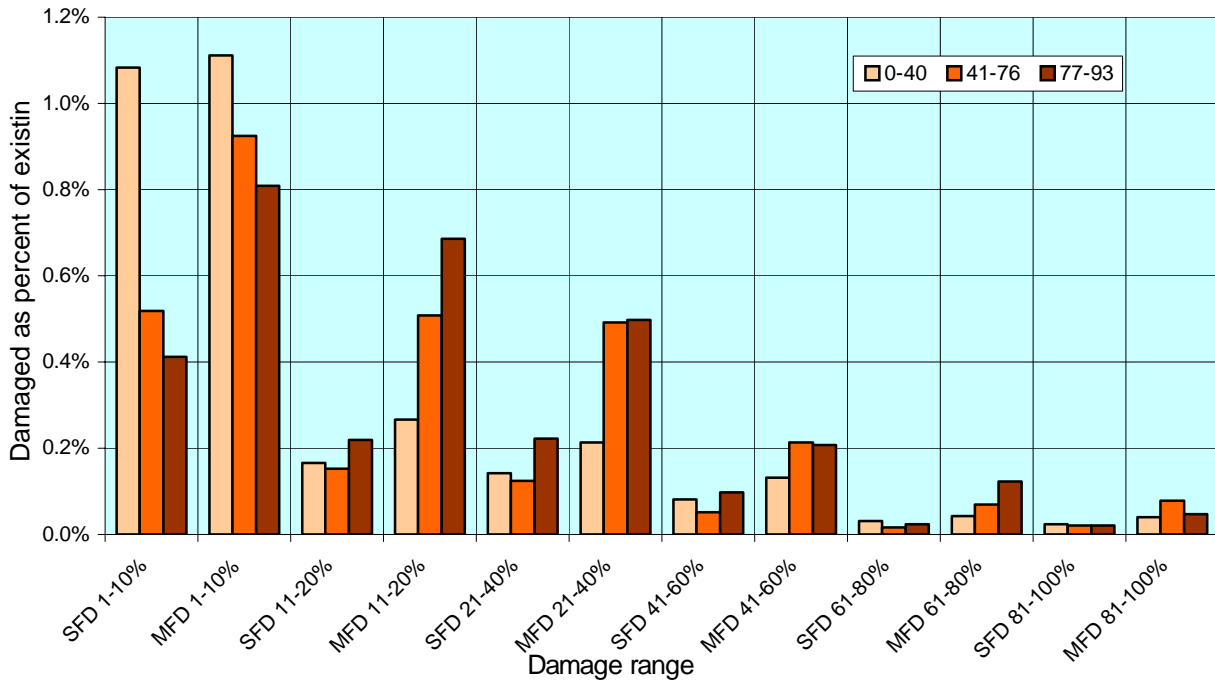
Graph 2: Damage Range by Year Built

Multifamily dwellings (MFD) built 77-93 performed worse than older ones (graphs 1-7); contrary to what should be expected, since 1976 UBC changes require more conservative seismic design. Poor performance may be due to inadequate construction observations by design professionals.
